## Road and Railroad Crossing Inventory

Little Coulee

U.S. Department of the Interior  
Bureau of Reclamation  
Great Plains Region  
Dakotas Area Office

September 2005

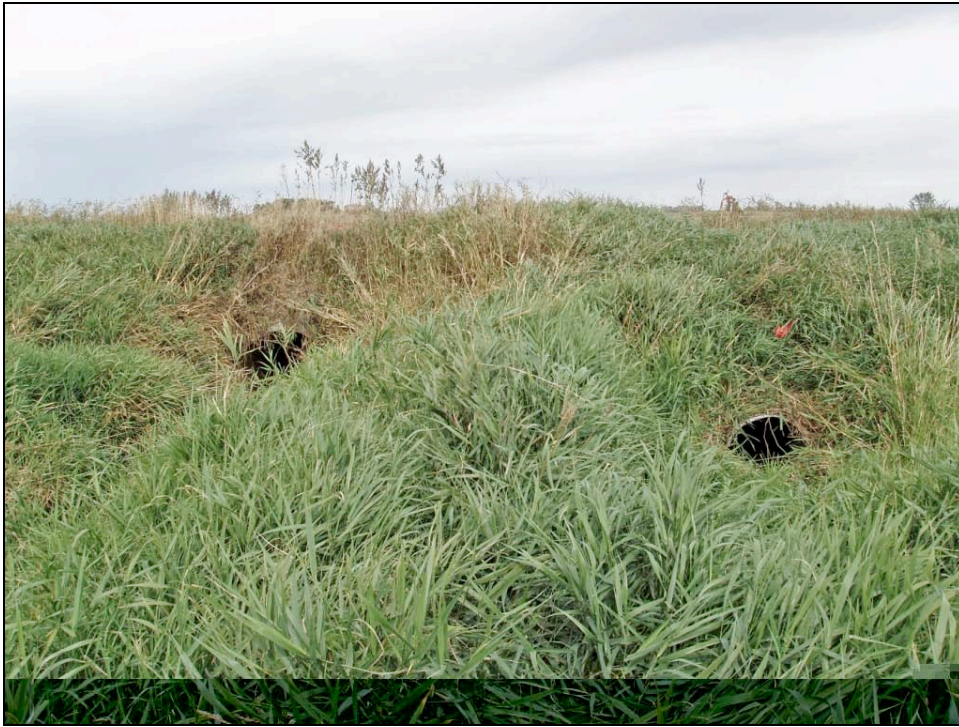
L34 Downstream side of two CMPs (24" & 48"), in good condition, east to west, no water & no water (09-14-05), Section 7 & 18, T159N, R69W, N 585912.52, E 2215072.51, elevation 1589.6 @ invert of 24" CMP, N 585924.14, E 2215055.39, elevation 1588.5 @ invert of 48" CMP.
